Nevada
Environmental
Restoration
Project

DOE/NV--1110

Post-Closure Inspection Report for
Corrective Action Unit 92:
Area 6 Decon Pond Facility,
Nevada Test Site, Nevada
For Calendar Year 2005

March 2006

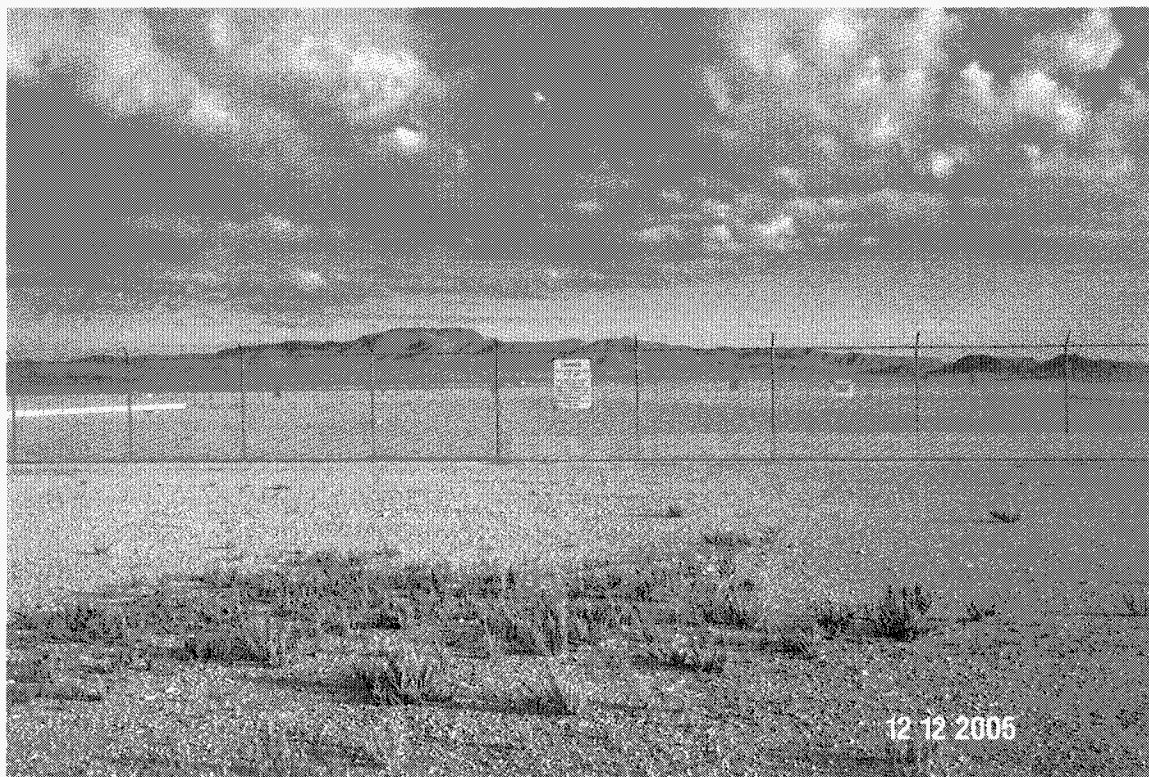
Photograph 26: Outside unit looking east, 12/12/2005

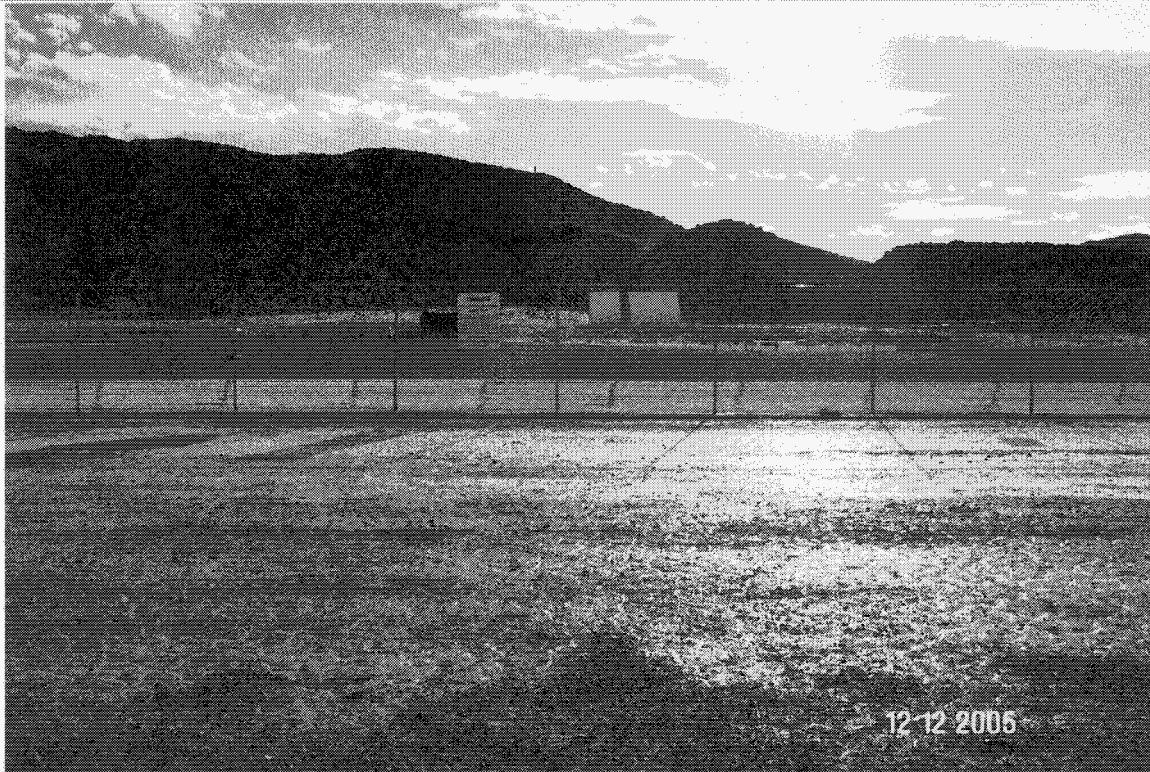
Photograph 27: Outside unit looking south, 12/12/2005

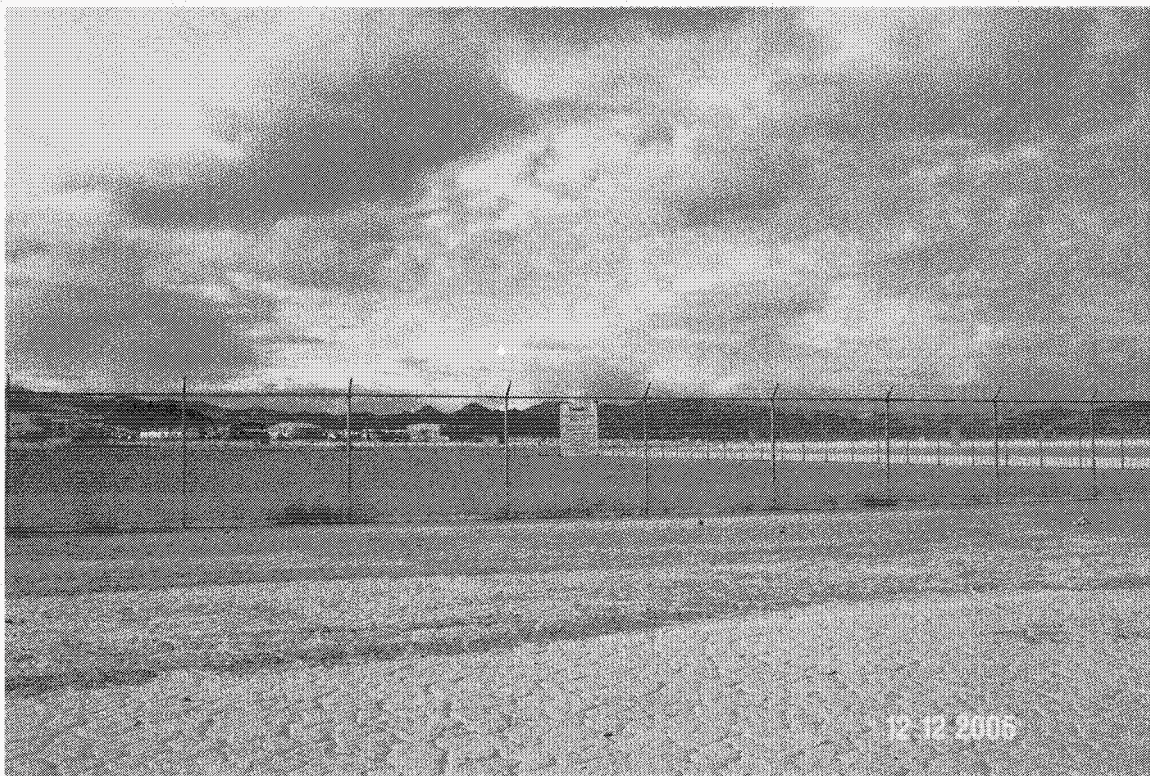
Photograph 28: Outside unit looking west, 12/12/2005

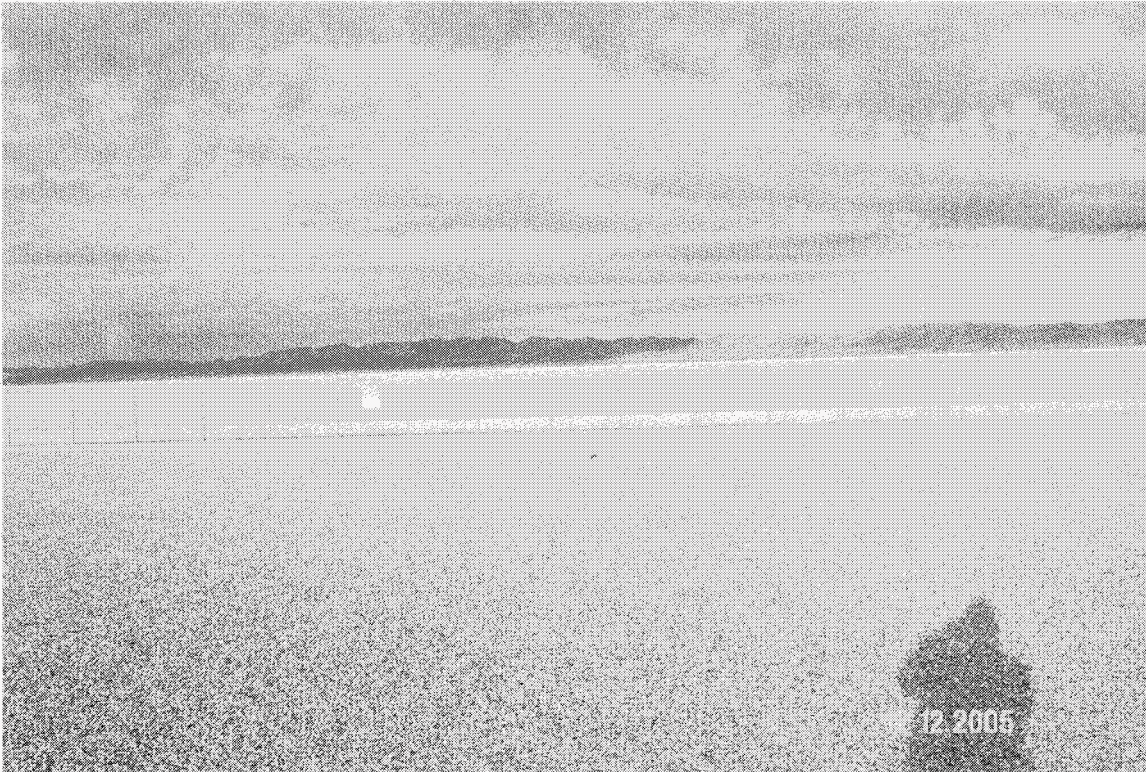
Photograph 29: Inside unit looking north, 12/12/2005

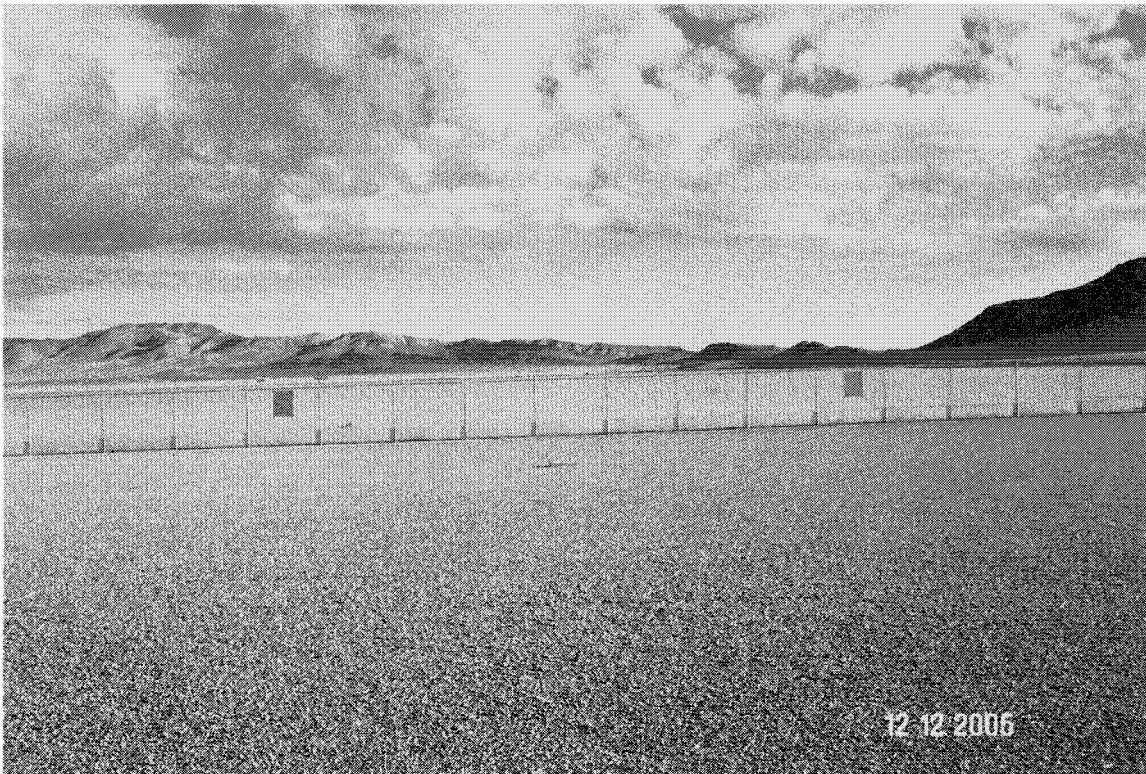
Photograph 30: Inside unit looking east, 12/12/2005

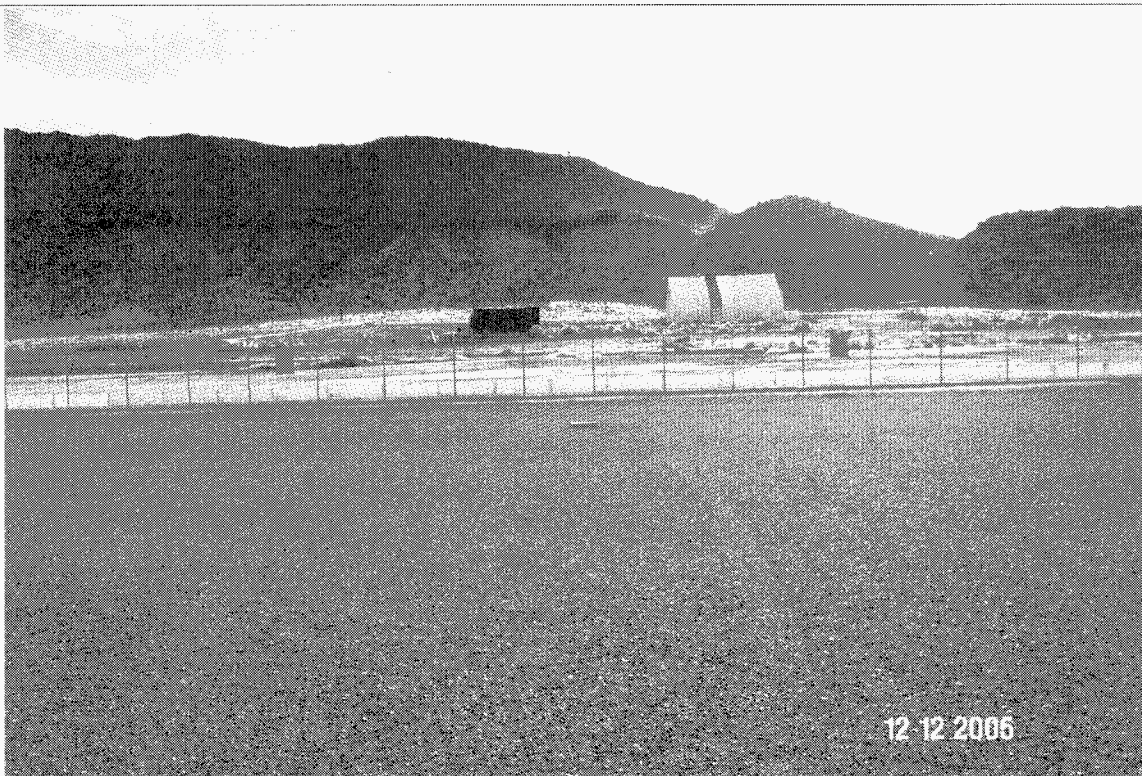
Photograph 31: Inside unit looking south, 12/12/2005

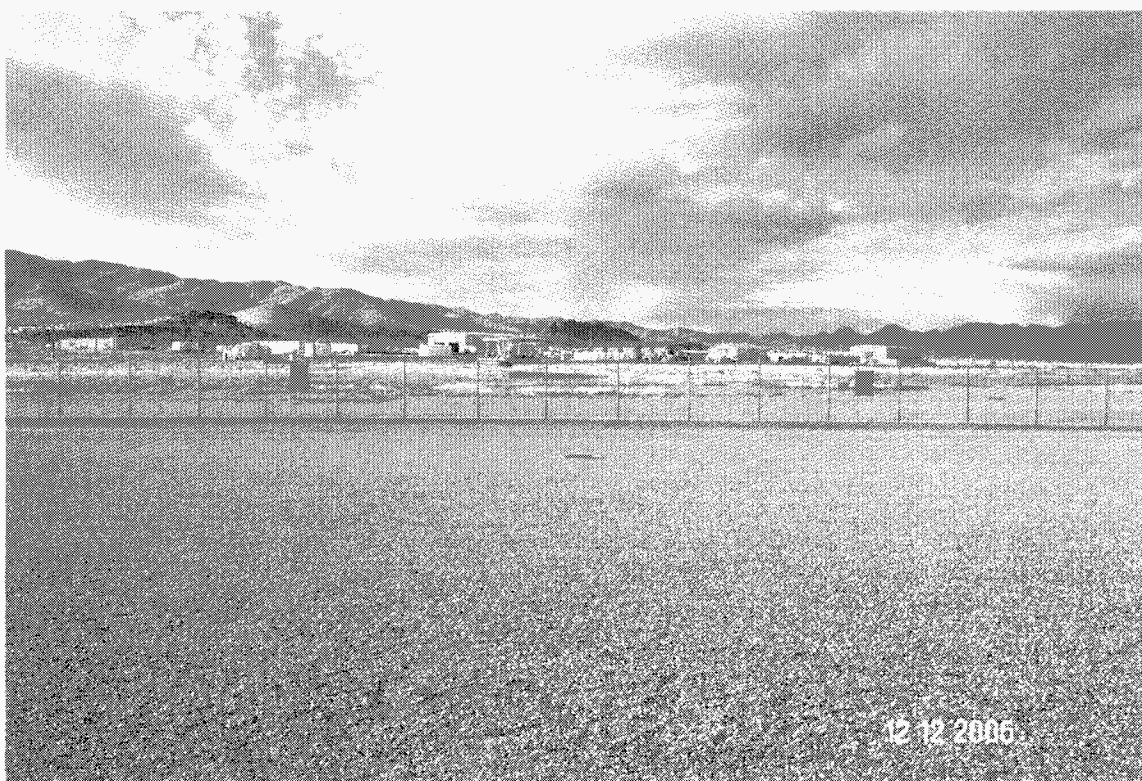
Photograph 32: Inside unit looking west, 12/12/2005
